**TECHNICAL NOTE**

INVESTIGATION OF A PROPELLANT FIRE AT  
MULWALA EXPLOSIVES FACTORY, JULY 1984

G. Bajinskis

ABSTRACT

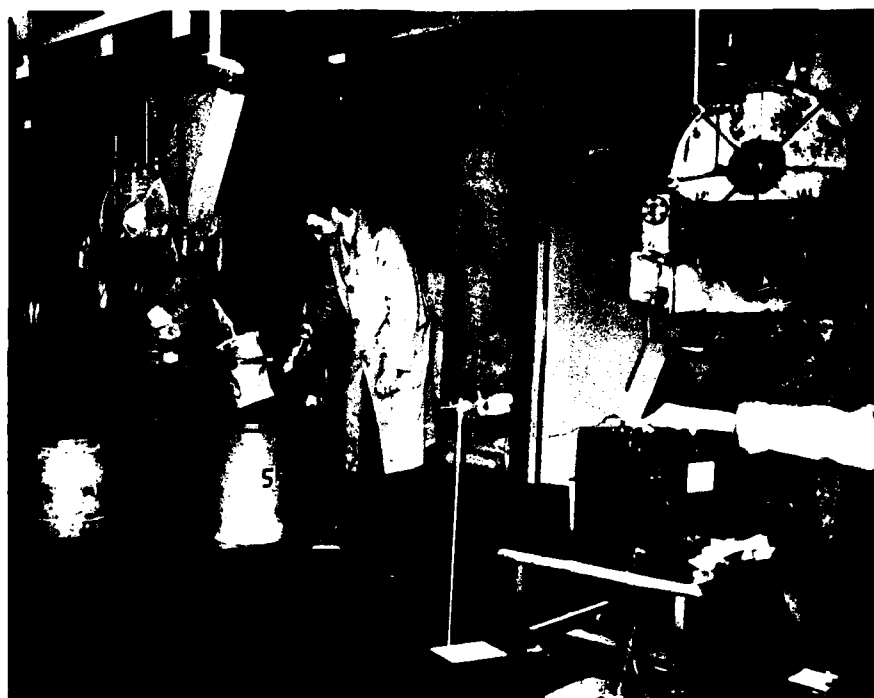
Fig. 1. Electrostatic charging tests on cut propellant in Building 234B. Photograph shows electrical discharging of cut propellant by earthing of meter input on the right of the photograph and the monitoring of surface charge by the operator prior to removal of electrode from the plastic bucket.

The potential of the cut propellant was monitored during the cutting operation with an electrostatic voltmeter linked to a probe at the bottom of the bucket. For measurements on fibre and metal buckets the probe was isolated from the base of the bucket with a thin sheet of plastic slightly larger than the probe electrode. The bucket was centrally placed on an earthed metal plate under the flow of cut propellant as shown in Figs. 1 and 2.
